FACILITY STATUS CHANGE FORM (for DOE/RL-2010-34 Facilities)

Date Submitted: 12/18/2013 Originator: Clay McCurley Phone: 942-8928	Area: 100-D Facility ID: 183D Water Treatment Plant Action Memorandum: General Hanford Site Decommissioning Activities	Control #: D4-100D-004
--	--	----------------------------------

D4 Project Facility Completion Form

Attachment 4

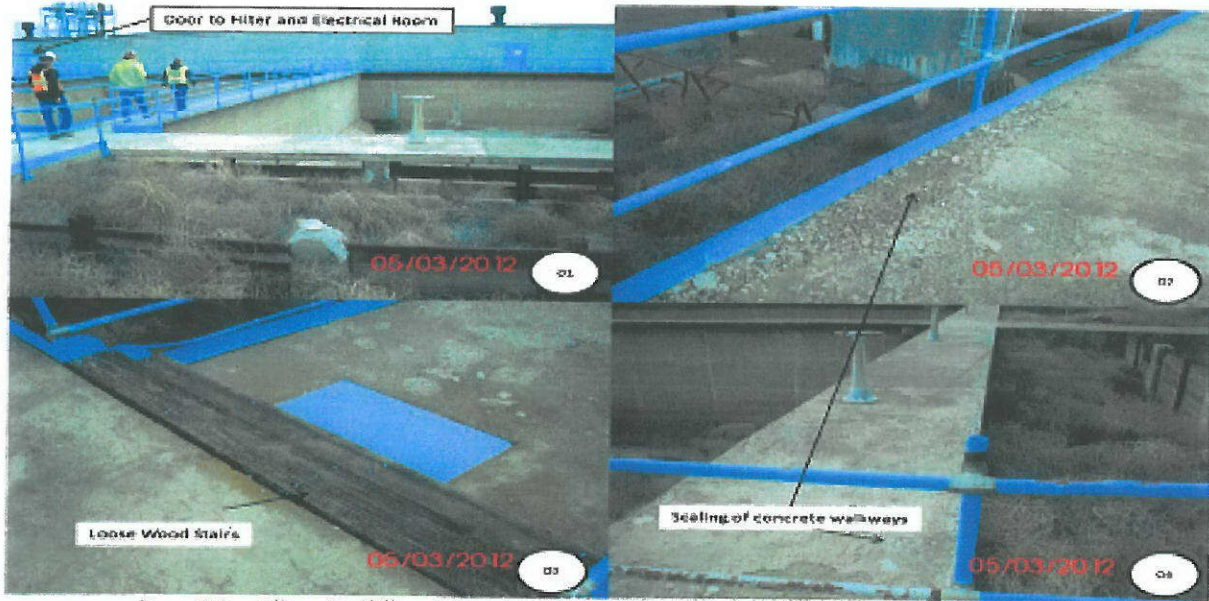
- **EXTERIOR STRUCTURE, PATHS AND WALKWAYS** – The walkways exhibit concrete scaling due to the being exposed to a corrosive environment. Some of the walkways exhibit concrete spall with exposed rebar. The rebar common to these areas exhibited moderate corrosion. There are some wooden stairs that were NOT secured properly that are tripping hazards.

- Item O1* – Filter Building Masonry Wall with NO significant Structural Degradation
- Item O2* – Scaling of Concrete Walkway
- Item O3* – Loose Wooden Stairs
- Item O4* – Scaling of Concrete Walkway

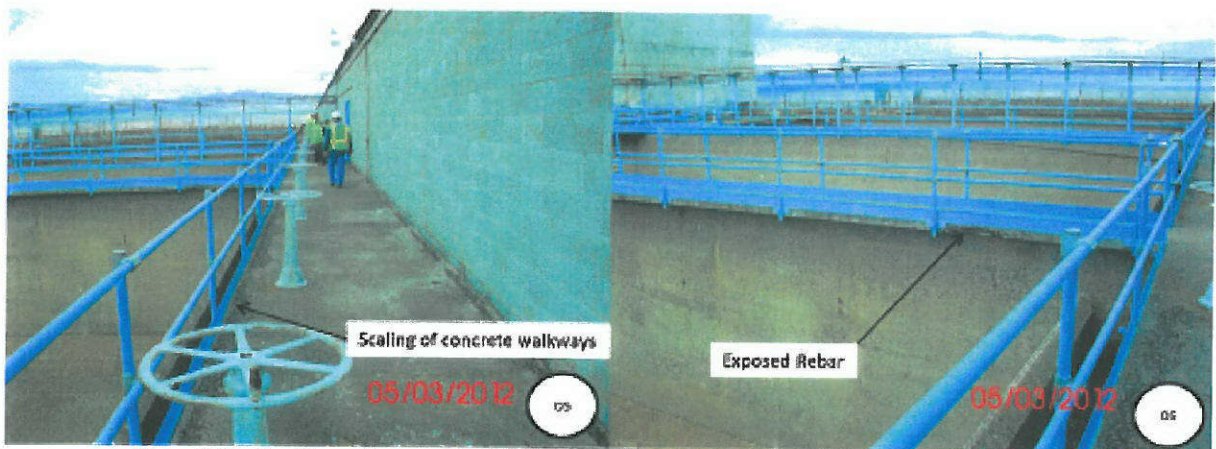
- Item O5* – Scaling of concrete Walkways (Note that metal handrails do NOT exhibit structural degradation)
- Item O6* – Concrete Spall on Walkway with exposed rebar

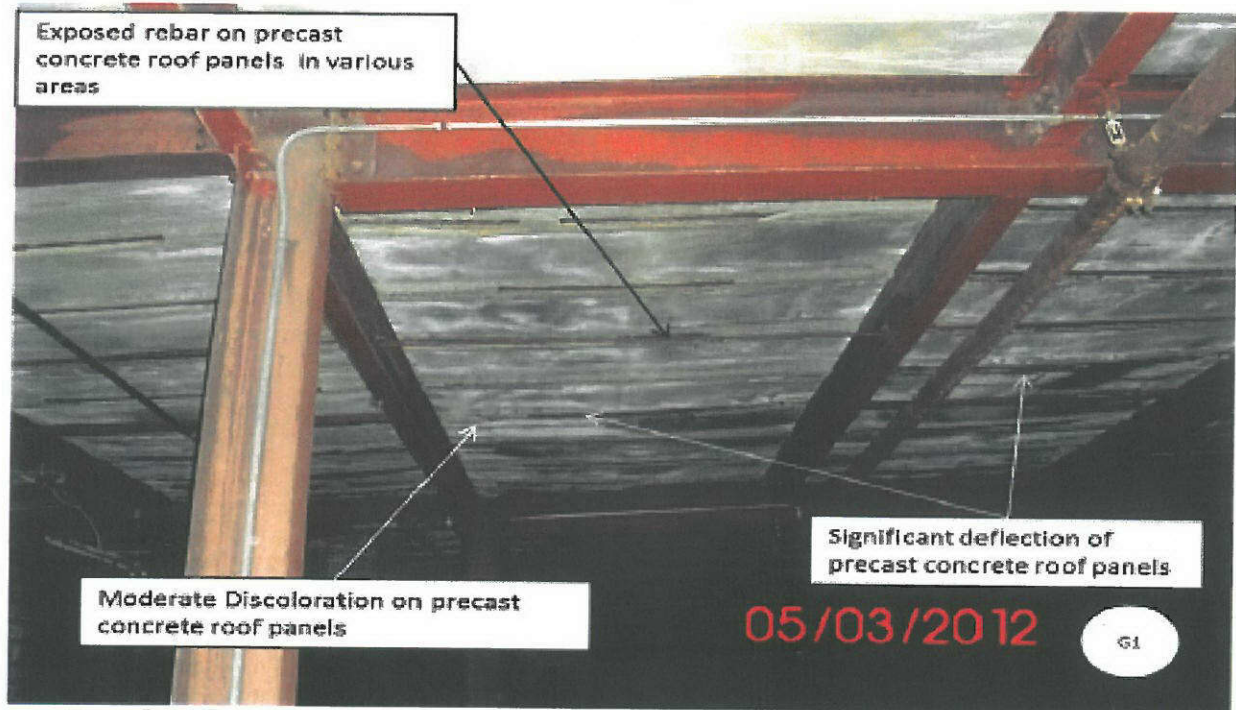
The pre-cast concrete roof panels exhibit severe degradation indicative of a structure that has been exposed to a corrosive environment. There is exposed rebar and significant deflections of the panels. In some cases, large pieces of the concrete panels have become detached and have fallen to the Filter Building floor. The panels also exhibited discoloration that is indicative of a potential chemical attack. These areas had "white stains" on their surfaces.

Item G1 – Significant structural degradation of concrete precast roof panels

Conclusion: Intrusive work scope, such as prepping for demolition, asbestos abatement, and hazardous material removal, are NOT allowed to be performed in the Filter Building, Pump Room and Electrical Switchgear Room because of the significant structural degradation. Non-intrusive entries for sampling are allowed in the Electrical Room area since it did NOT exhibit significant structural degradation; however, an alternate path needs to be taken. Consult qualified Engineering personnel for further evaluation of the alternate path.

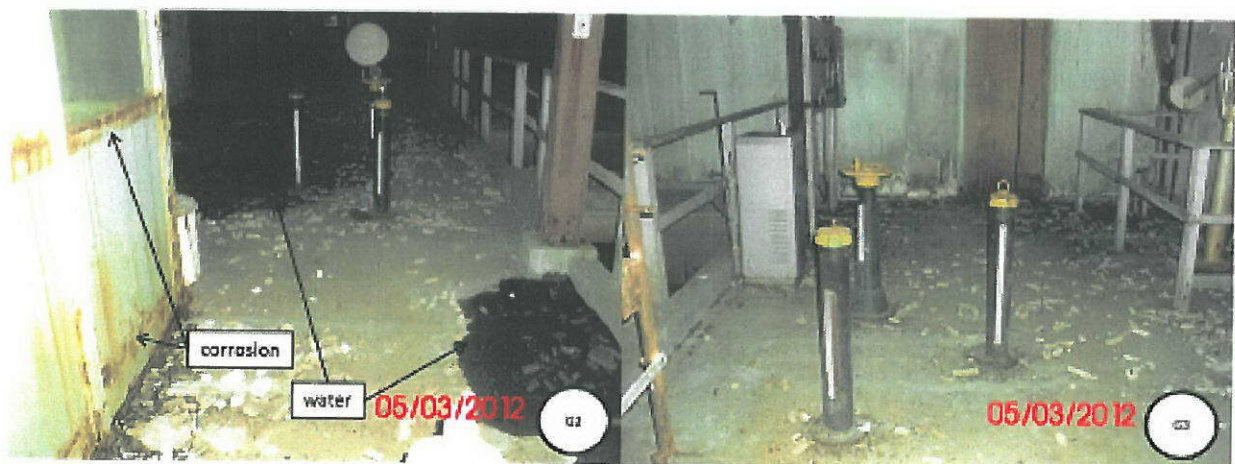
Item G2 – Corrosion on metal wall panels and presence of water

Item G3 – Evidence of biological hazard

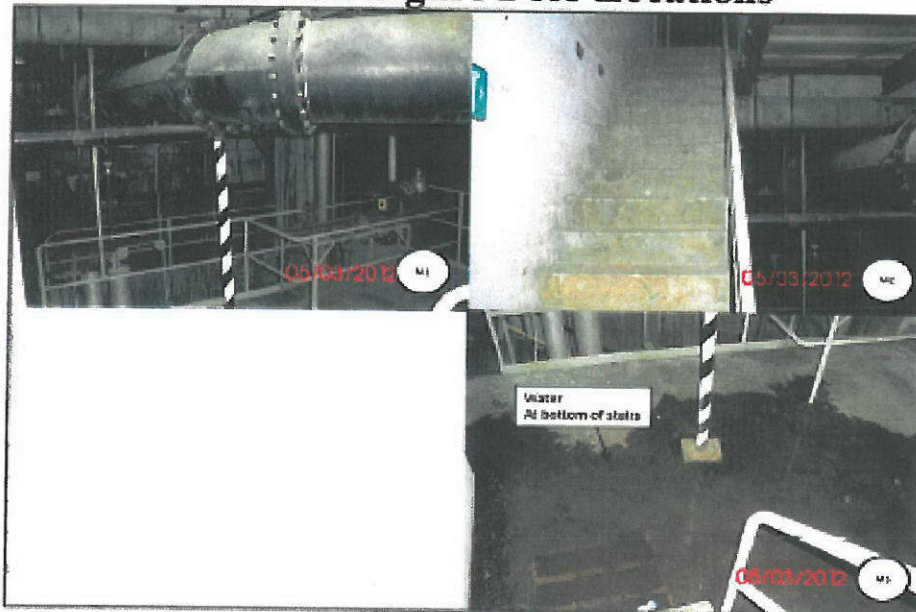
Item M1 – Structures and Components with NO significant Structural Degradation

Item M2 – Concrete Stair with NO significant Structural Degradation

Item M3 – Bottom of stairs with pooled water, NO significant Structural Degradation

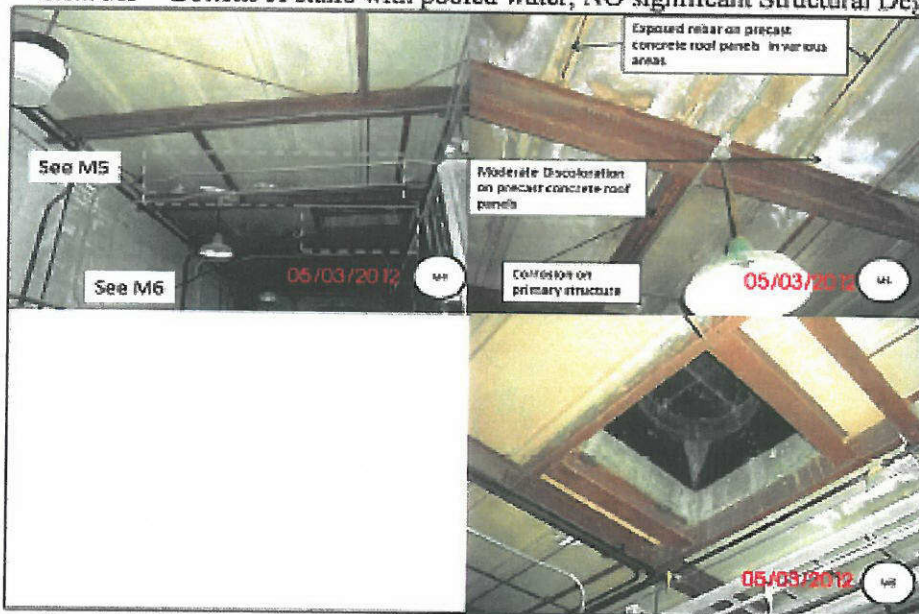
The pre-cast concrete roof panels exhibit severe degradation. The rebar of these panels were exposed to the environment. There were also panels which exhibited discoloration. These areas had "white stains" on its surface.

Item M4 – Roof area with minor discoloration, masonry walls have NO significant structural degradation

Item M5 – Metal Beams with moderate corrosion, exposed rebar, and discoloration

Item M6 – Penetration with NO significant structural degradation

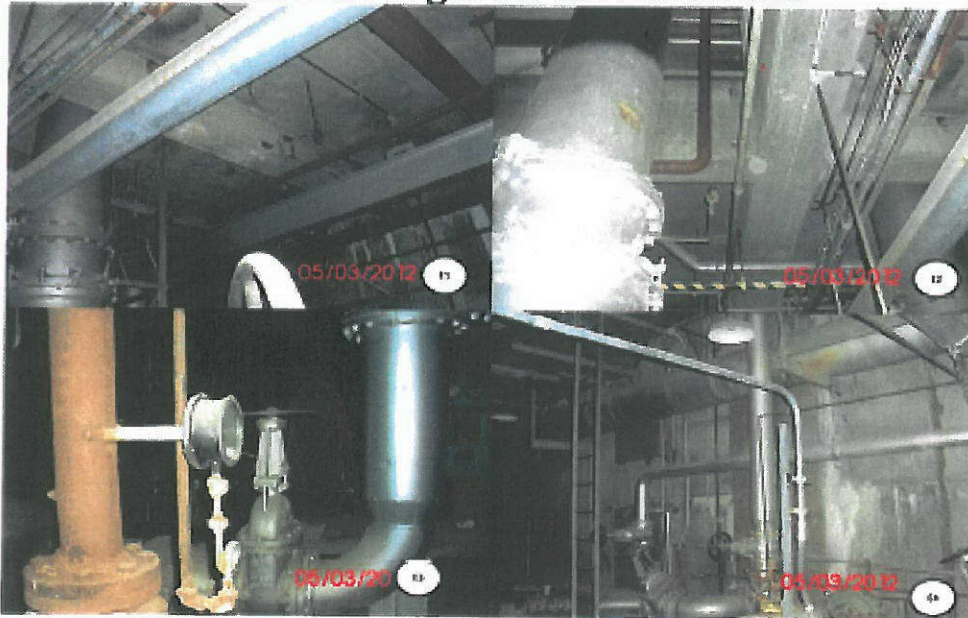
Item E1 – Concrete Roof with NO significant Structural Degradation

Item E2 – Concrete Beam with NO significant Structural Degradation

Item E3 – Structures and Components with NO significant Structural Degradation

Item E4 – Walls with minor Discoloration

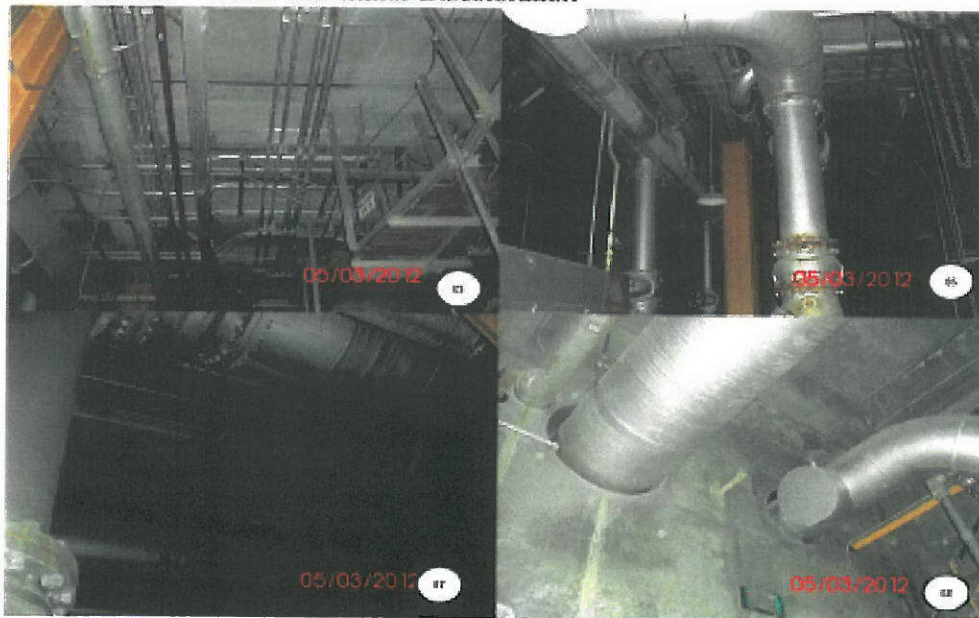
Item E5 - Concrete Roof with NO significant Structural Degradation

Item E6 – Structures and Components with NO significant Structural Degradation

Item E7 – Concrete Roof with NO significant Structural Degradation

Item E8 – Wall with Pipe Penetrations with NO significant Structural Degradation

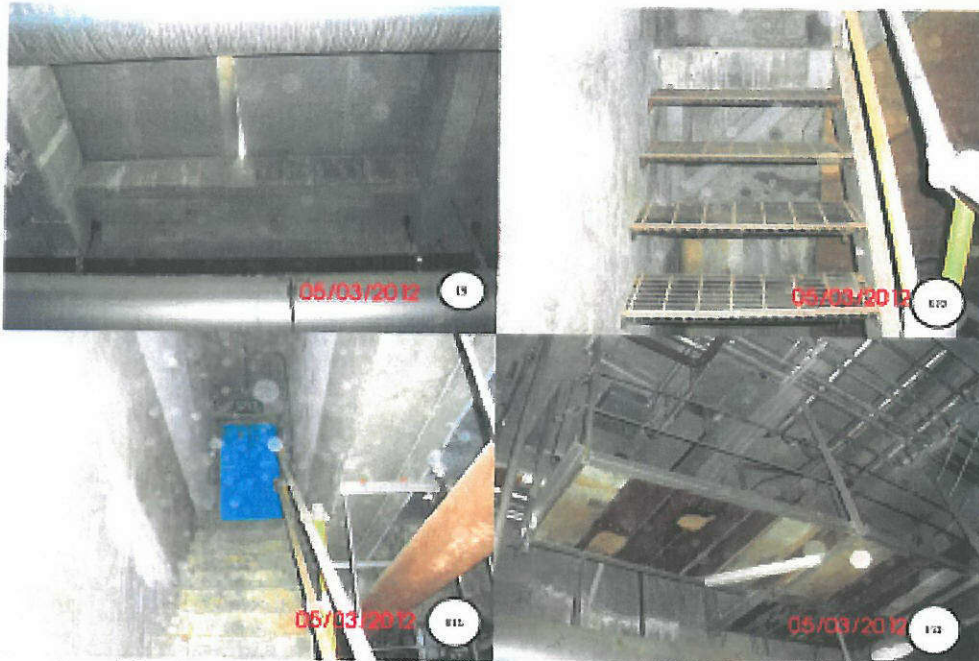
Item E9 - Concrete Roof Penetration with NO significant Structural Degradation

Item E10 - Metal Stairs NO significant Structural Degradation

Item E11 - Concrete Stairs and Entry Way with NO significant Structural Degradation (Note: Particulates in room)

Item E12 - Balcony with NO significant Structural Degradation
